Environmental Impact Assessment

Coral Gardens Dune Replenishment PR 16651

TCI BLUE LTD
Strata Plan 36
Providenciales, Turks and Caicos Islands

December 2024

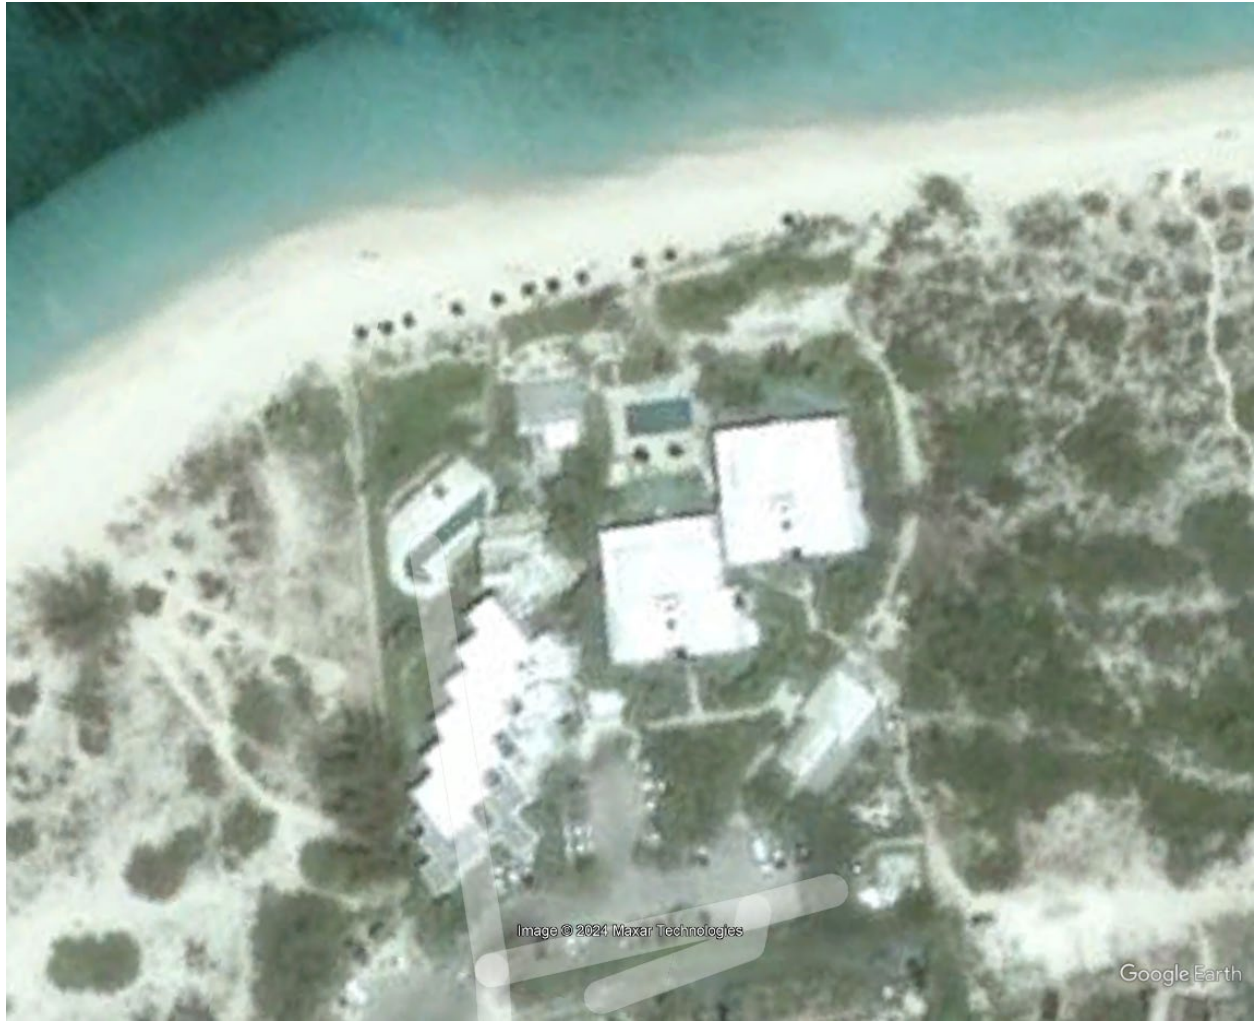
Figure 2-1. Site Conditions circa 2003. Note approximate 30-foot-wide vegetated dune fronting the café and property.

In review of historic imagery, the shore and dune line in the project vicinity has exhibited a recessionary trend since at least 2003 (Figure 2-1). The dune line has receded on the order of 30 feet landward resulting in the loss of the primary dune profile and landward migration of the active beach into the built environment. The beach profile has receded a similar distance and current beach widths are on the order of 80 feet as measured from the dune scarp to the approximate MHW location. This represents a compressed beach profile in comparison to more stable beaches on the northern shore of Providenciales.

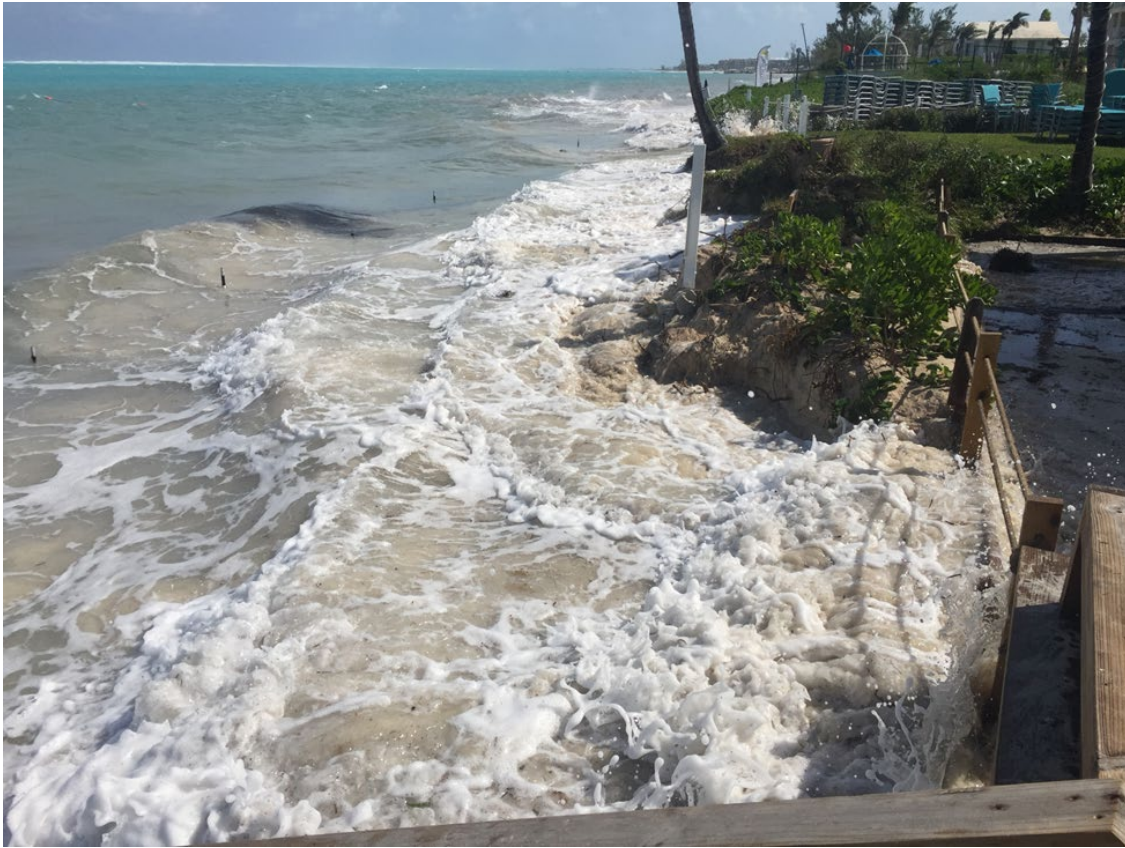
Photo 2-1. Dune at Coral Gardens Looking East during high sea erosional event. Date of Photo: March 4, 2018

Two hurricanes in 2017, Irma and Maria, altered the previous dune structure. The dune structure was severely eroded due to hurricane related storm surge and wave conditions. In its current state, the property is subject to wave runup into the dune line and café during both strong winter storms and tropical cyclone events. Photo 2-1, which was taken in March 2018, is representative of storm conditions which impact both the dune line and café.

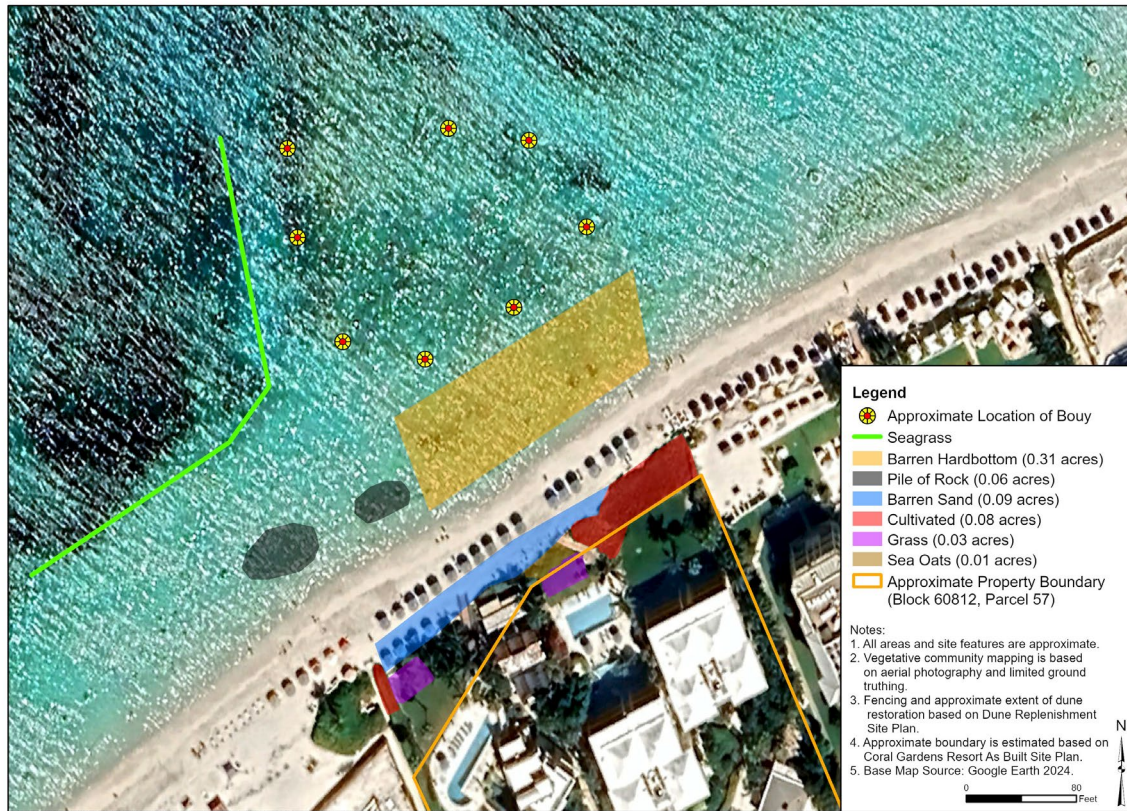
Figure 2-2. Identified Fractured Habitats.

The qualitative assessment was conducted within the defined location as shown in Figure 2-2. Within this area, the marine habitats and ecosystems as well as observed flora and fauna were observed and noted. The cumulative list of the marine flora and fauna identified is included in Appendix K.

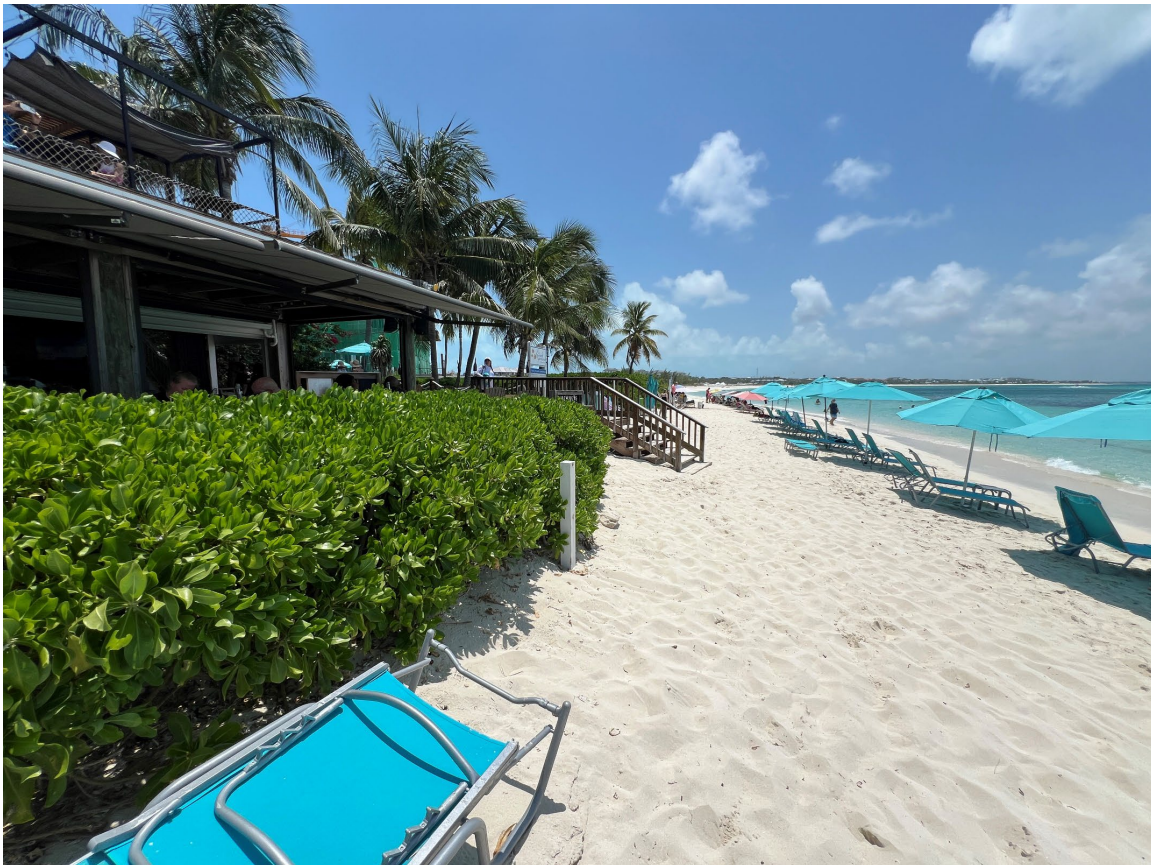
Photo 2-2. West View Behind Somewhere Cafe. Date of Photo: May 16, 2024

The beach width is too narrow to support sufficient habitat for a multitude of species, and it is subject to erosion. The upper limit of this community transitioned into the resort landscaping due to the lack of a significant dune.

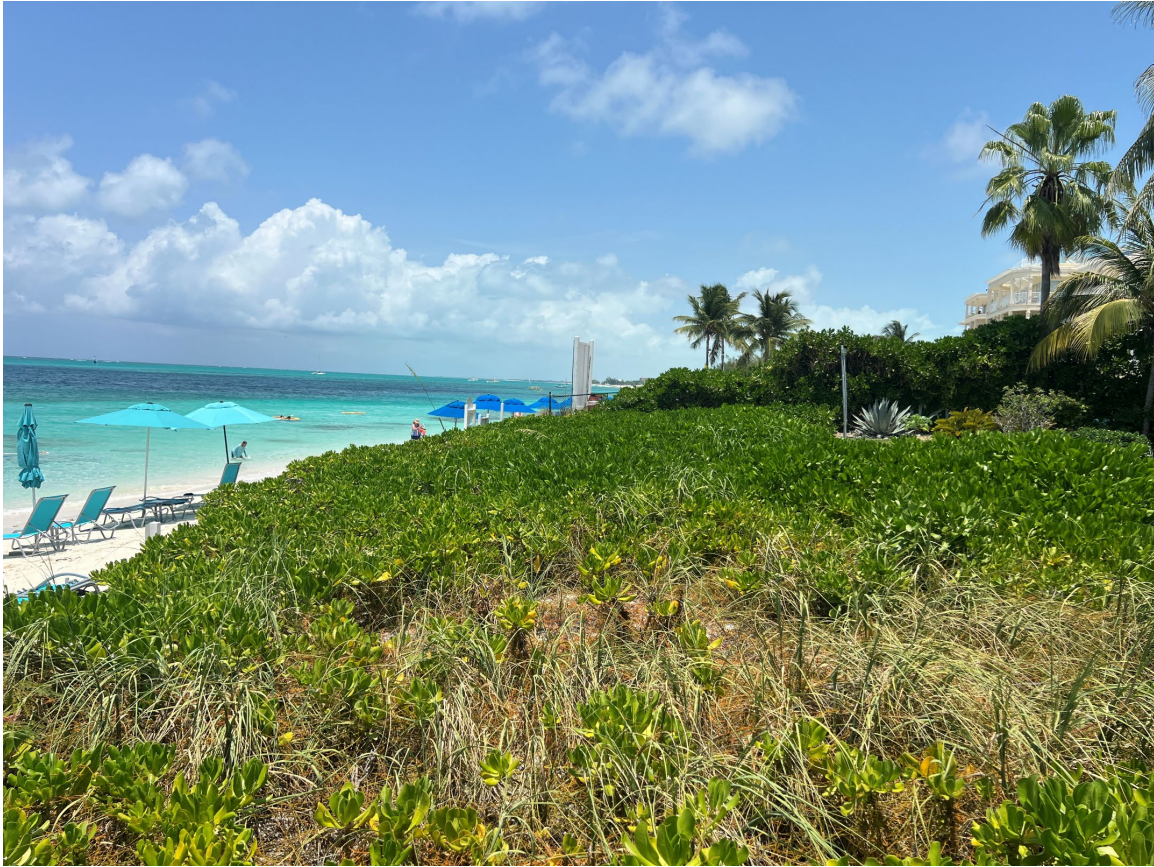
Photo 2-3. Existing Dune with Invasive *Scaevola taccada*. Date of Photo: May 16, 2024

The small portion of native plant species present consisted only of sea oats (*Uniola paniculata*) intermixed with the more dominant invasive species noted above. The resort uses dune walk-over structures that keeps guests from trampling the vegetation in the dunes.

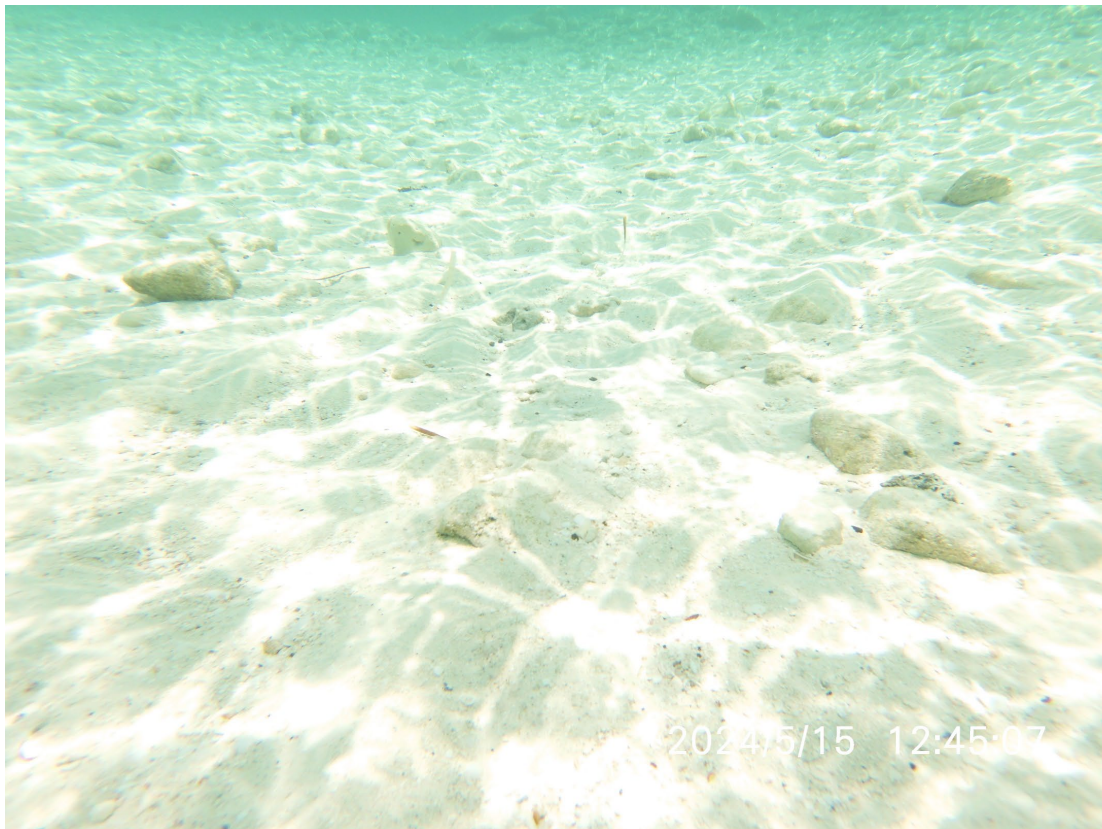
Photo 2-4. Barren Sand with Scattered Rubble.
Date of Photo: May 15, 2024

This habitat is highly dynamic; therefore, the sediment is likely to be continually moved around by prevailing waves and nearshore currents. This dynamic sediment environment prevents the establishment and long-term survival of most epibenthic resources.

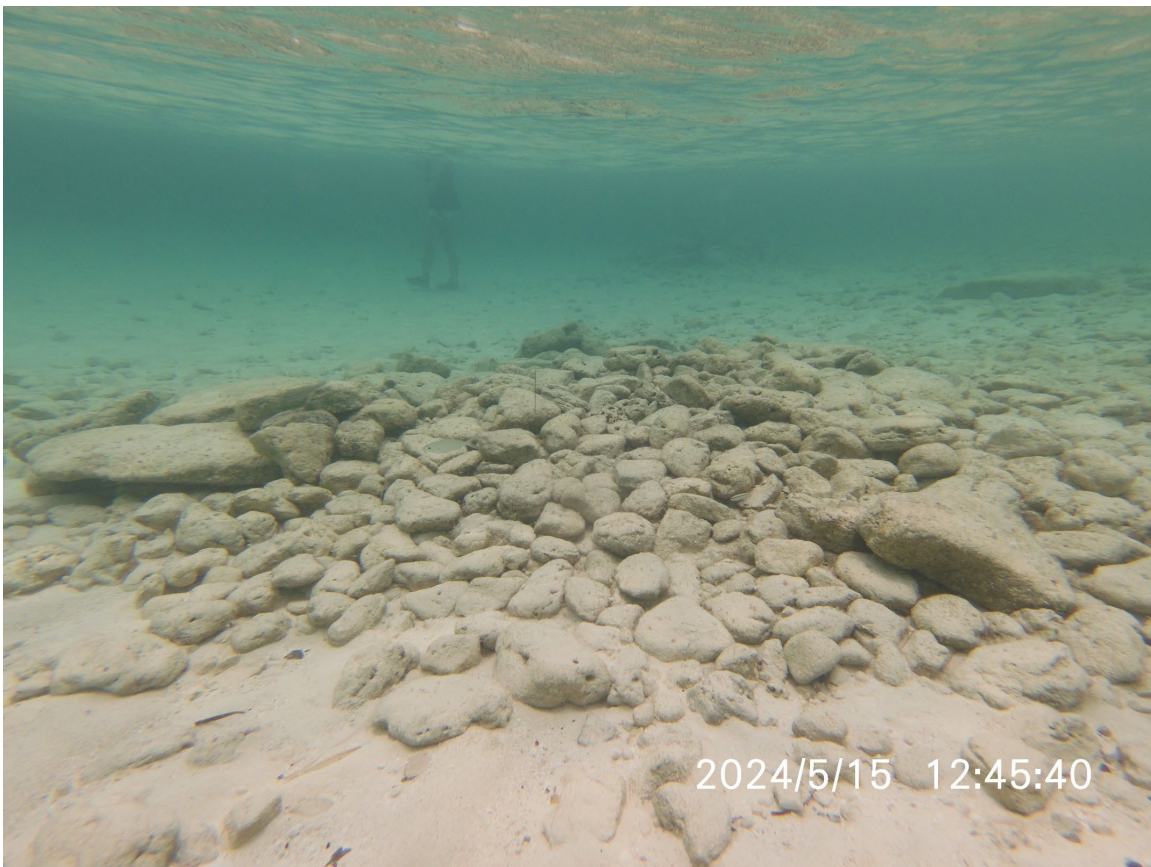
Photo 2-5. Rubble Piles in the Nearshore. Date of Photo: May 15, 2024

Substrate consisting of mostly continuous rubble piles and broken pavement was present in the central portion of the assessment area, just waterward of the barren sand area. The barren sand

This marine system is also a highly dynamic area where the sand is regularly moving. Similarly to the barren sand habitat, the significantly low abundance of epilithic marine life (i.e., algae, corals, sponges, etc.) suggests that the area is too dynamic to support establishment and long-term survival of complex benthic communities.

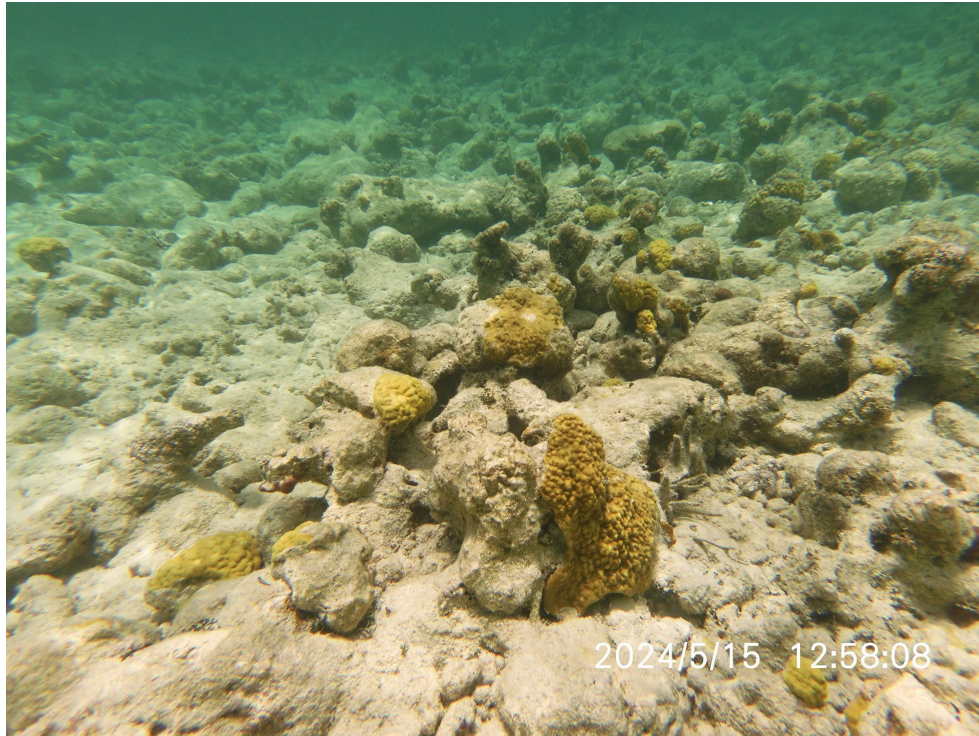
Photo 2-7. Typical Reef, Scattered Coral on Barren Rock.
Date of Photo: May 15, 2024

As the assessment extended farther offshore, a hardbottom reef feature was observed, commonly known as the Coral Gardens Reef. This reef area is located in the center section of the assessment area, seaward of the rubble piles and broken pavement. This habitat showed an increase abundance of epilithic life, which gives rise to the increased species richness and diversity. Macroalgae, sponges, epifauna (small mobile organism living on the surface of marine structures), and scattered corals were present in this habitat.

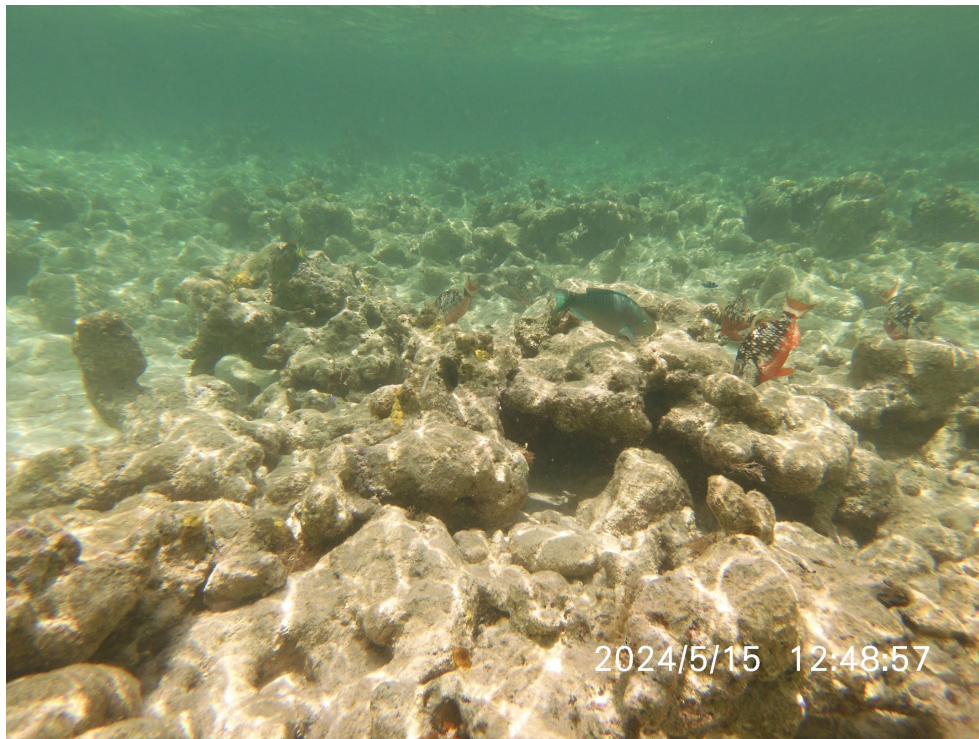
Photo 2-8. Barren Rock with Fish.
Date of Photo: May 15, 2024

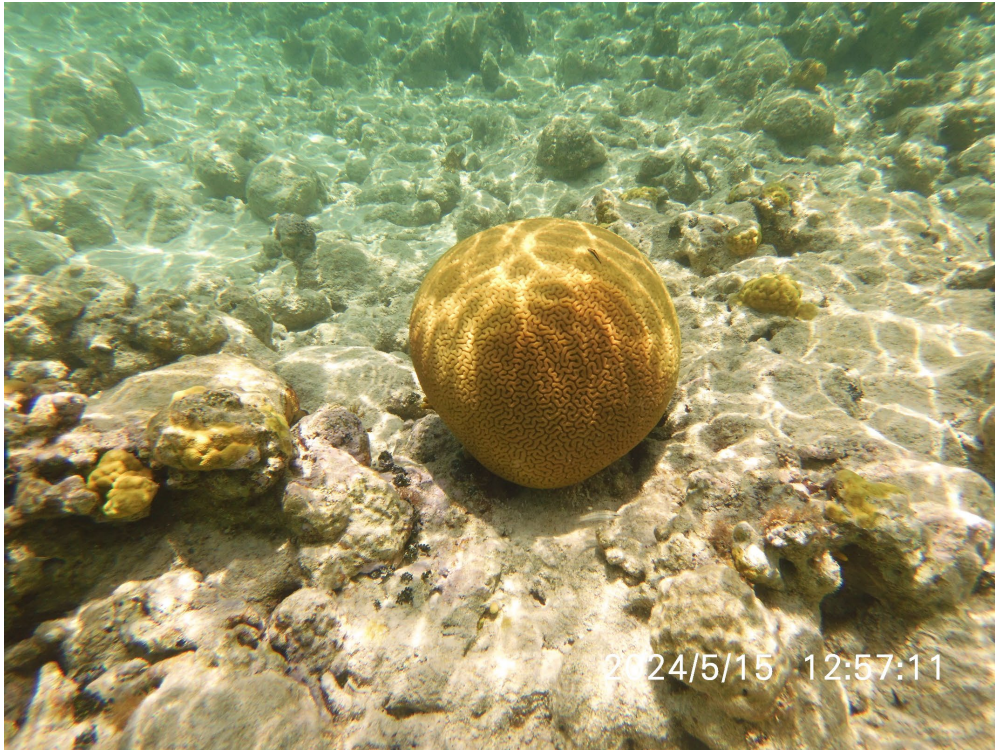
Photo 2-9. Symmetrical Brain Coral.
Date of Photo: May 15, 2024

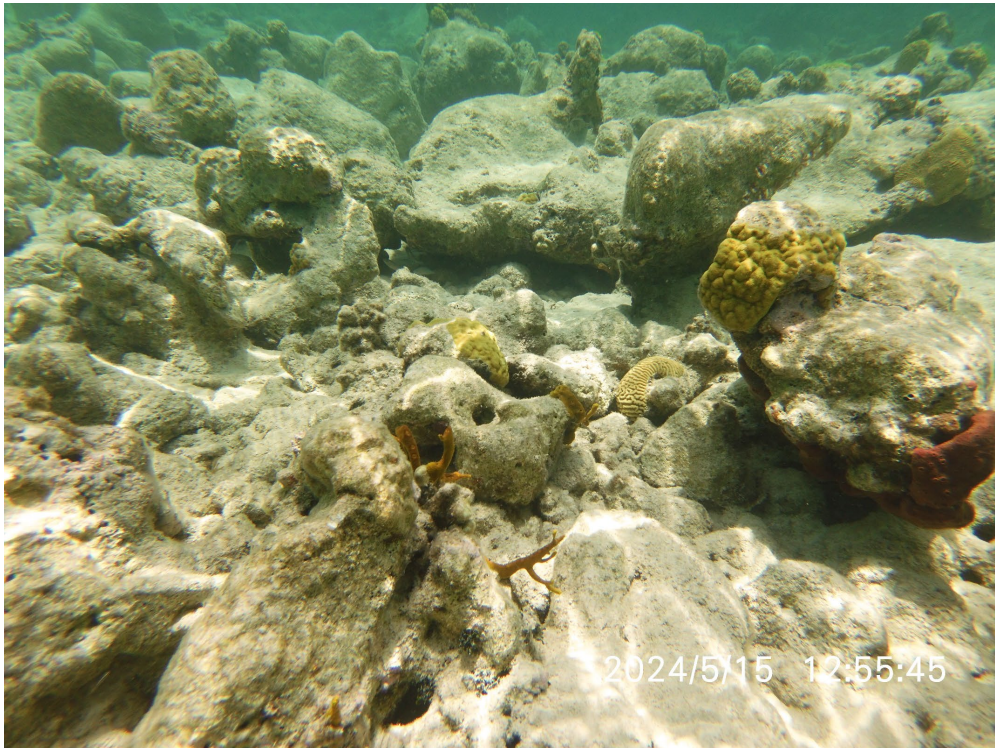
Photo 2-10. Typical Reef Photo, Barren Rock with Scattered Coral.
Photo: May 15, 2024

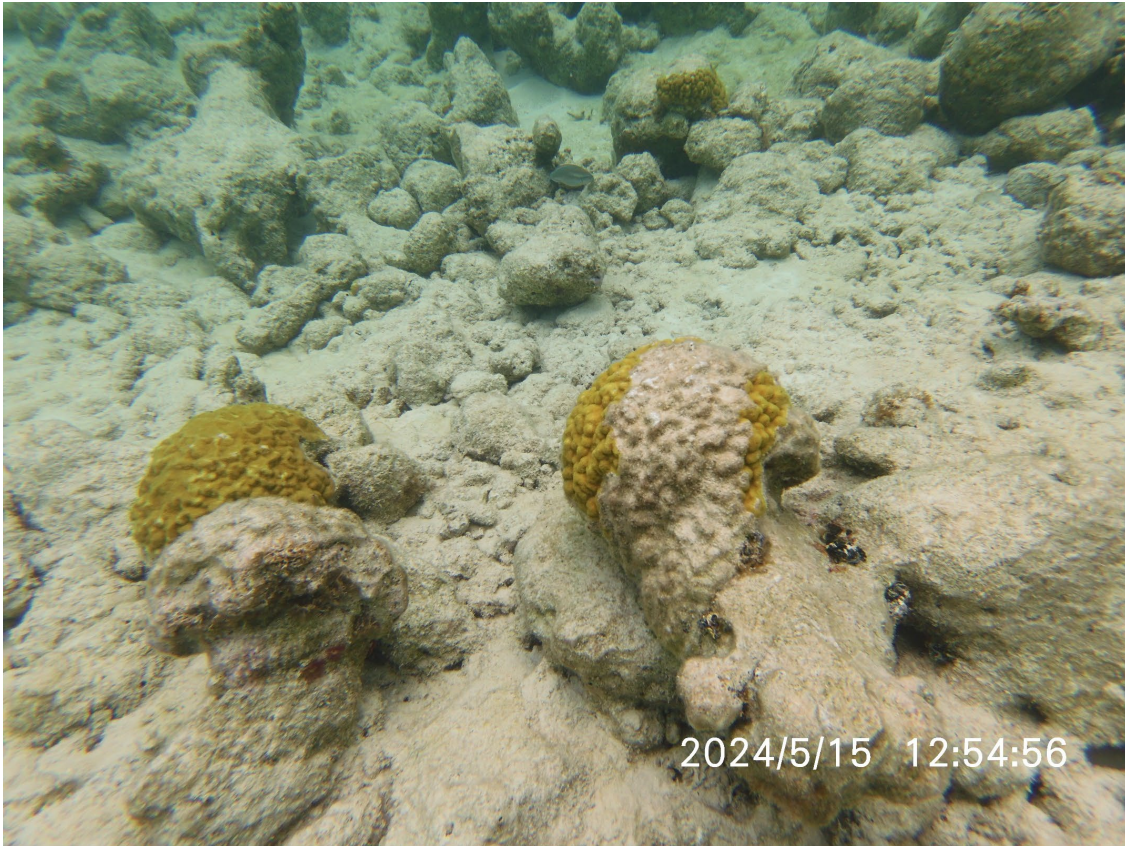
Photo 2-11. Mustard Hill Coral with evidence of tissue loss (right).
Date of Photo: May 15, 2024

Hard (stony) corals were observed throughout the reef system, although scattered the presence of corals was consistent. Species of corals observed within the assessment area consisted of mustard hill coral (*Porites astreoides*), massive starlet coral (*Siderastrea siderea*), symmetrical brain coral (*Diploria strigosa*), and knobby brain coral (*Diploria clivosa*). The qualitative assessment showed possible indication of previous coral loss as well as symptoms of coral stress, though no specific, identifiable presentation of disease. While limited physical presentation of active stress was evident on isolated corals, the level was not atypical of anticipated levels particularly given the nearshore location and time of year.

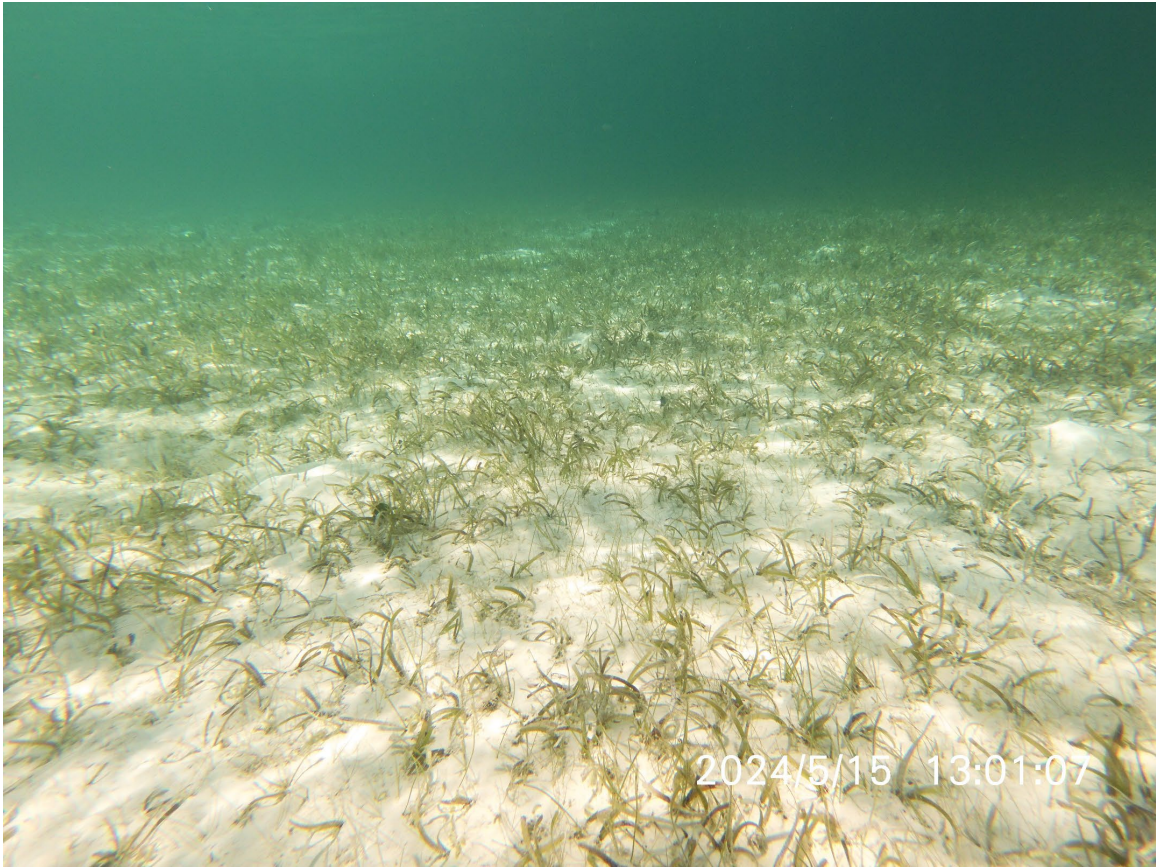
Photo 2-12. Moderately Dense Seagrass Bed Adjacent to Coral Gardens Reef.
Date of Photo: May 15, 2024

Although the edges of the SAV bed were eroded in some areas and partially covered with sand in others, the central portions were in good condition and healthy.

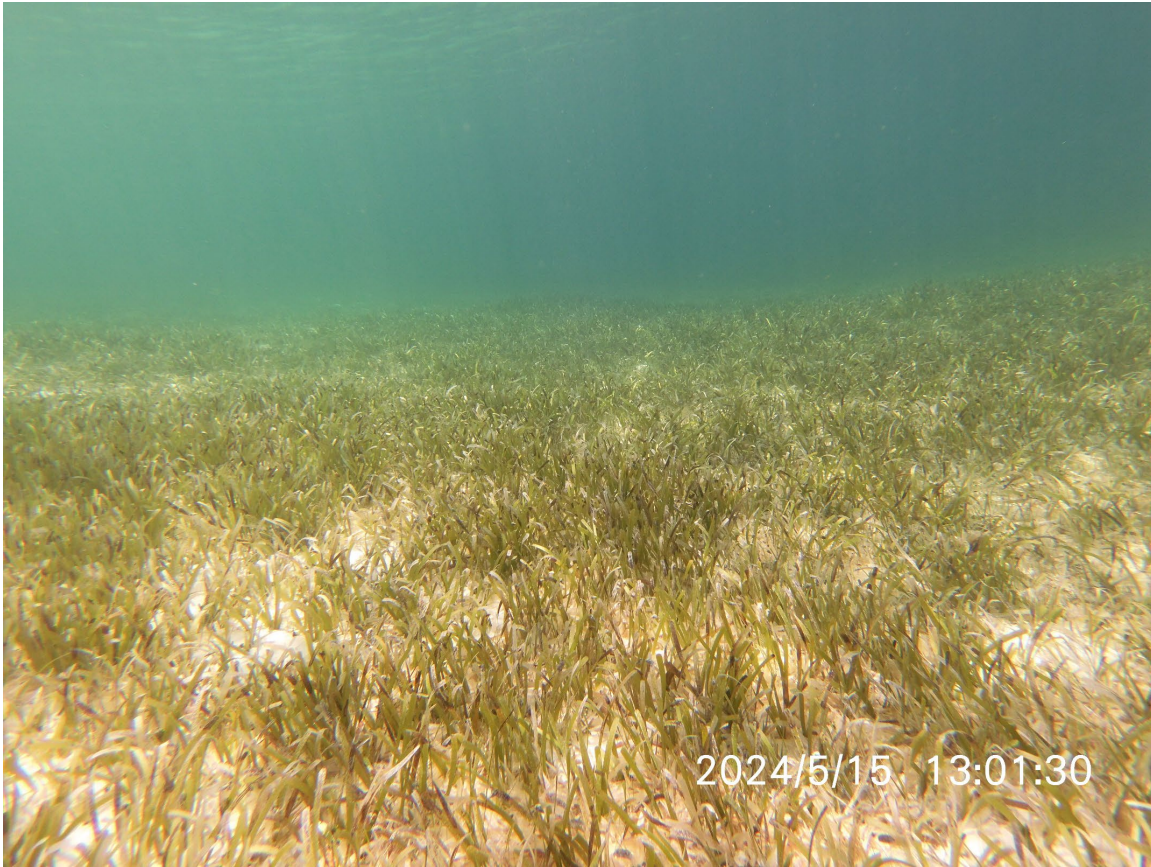
Photo 2-13. Dense Seagrass Bed Adjacent to Coral Gardens Reef.
Date of Photo: May 15, 2024

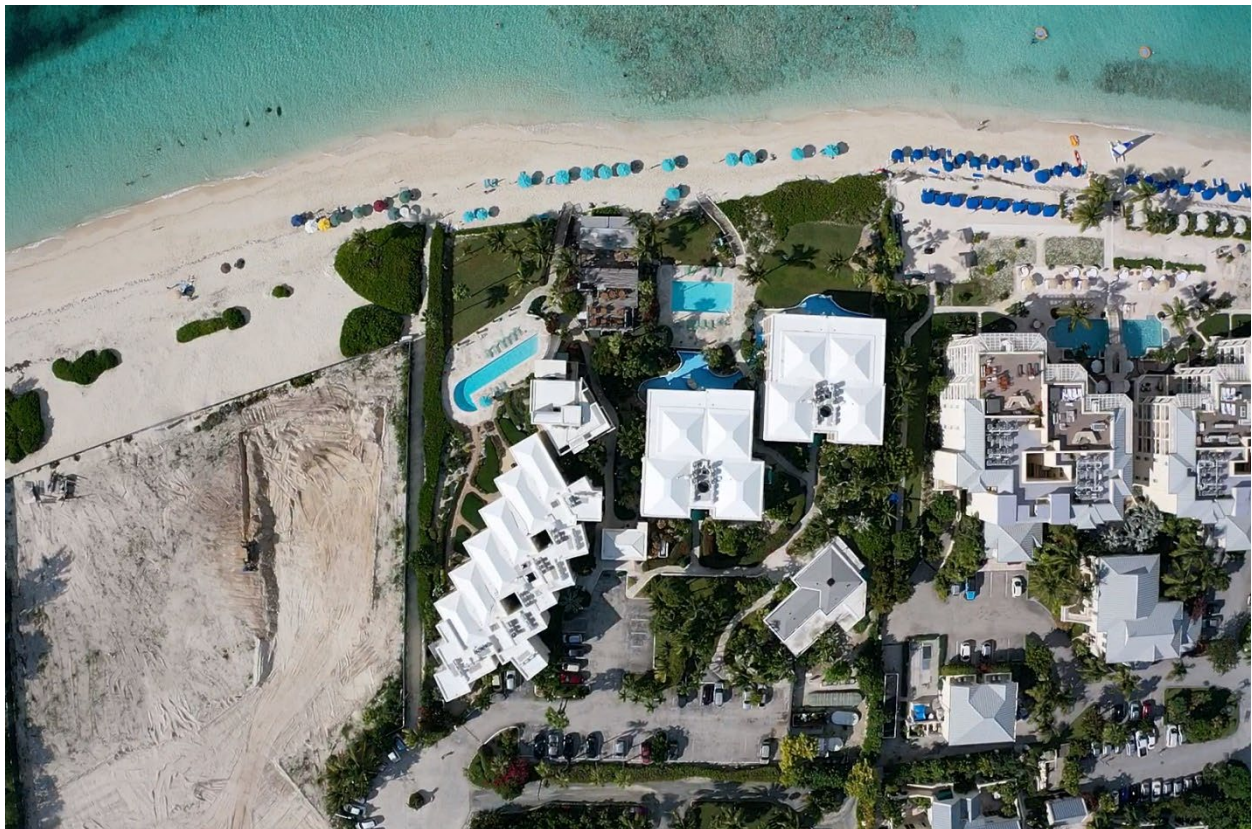
Figure 2-3. Coral Gardens Resort, Centre, Showing Neighbouring Properties.

The current aesthetics of the shoreline consist of a sandy barren beach followed by the upland resort property. The existing dune feature only exists on the east end of the property and is heavily vegetated with invasive *Scaevola tacadda*. Along the central and western portion of the property, the beach intersects the Somewhere Café and the resort property, with no dune feature present.
